**Flood Control Project Maintenance
Levee Inspections**
LMA District Cover Sheet
Spring 2018 Levee Inspection Results

Marysville Levee Commission

Spring 2018 Levee Inspection Results

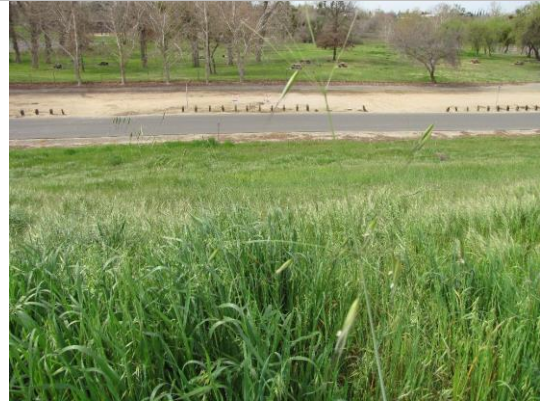
Photo 1 of 3 : UCIP_SP_2018_40940_69802.jpg

LM Start	0.87	Rating **	M	Issue No.	16 (cont)
LM End	0.87	Issue Type +	En	Location *

View of waterward slope.

LM Start	0.87	Rating **	M	Issue No.	16 (cont)
LM End	0.87	Issue Type +	En	Location *	
Category	Supplemental			GPS Latitude/Longitude	
				Start	End
Item	DWR UCIP Field Study			39.138269 °	39.138269 °
				-121.599004 °	-121.599004 °
DWR ID					
Comment Code					
Inspector Comment					
FS_ID:40940					
DS_ID:19123					
EP_NO: N/A					
Repair Type: Non-Urgent					
Crossing Status: Indicator Found					
UCIP Comments: Unable to tell if crossing goes through levee; according to Frank Miller crossing does not cross levee. Need to contact owner to confirm alignment.					
FIELD_STRUCT_DESC: Fiber optics communication line of unknown material through levee at an unknown depth below the crown. Marker on waterside (WS) shoulder. [Additional Reference(s): DWR Levee Logs, 1993 and 2005]					
FS Date: 3/15/2013

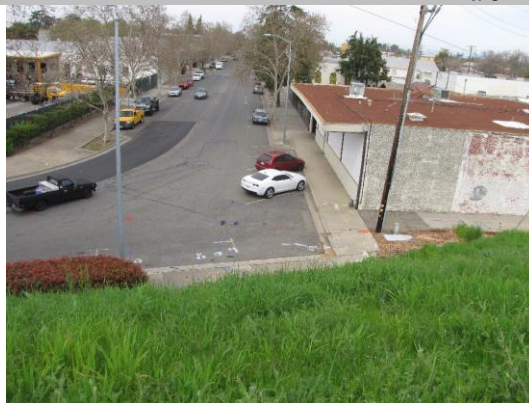
Photo 1 of 2 : UCIP_SP_2018_40969_72683.jpg

LM Start	0.47	Rating **	M	Issue No.	45
LM End	0.47	Issue Type +	En	Location *	
Category	Supplemental			GPS Latitude/Longitude	
				Start	End
Item	DWR UCIP Field Study			39.135932 °	39.135932 °
				-121.585529 °	-121.585529 °
DWR ID					
Comment Code					
Inspector Comment					
FS_ID:40969					
DS_ID:19133					
EP_NO: 1983					
Repair Type: Non-Urgent					
Crossing Status: Indicator Found					
UCIP Comments: Need to contact owner. Unable to determine if crossing is still in use.					
FIELD_STRUCT_DESC: 0.75-inch water line through the levee at an unknown depth through the levee. Water meter at landside (LS) toe. Extends from nearby buildings, bunkers, suction dredge on waterside (WS). (Permit No. 1983, 1959-Yuba River Sand Company). [Additional Reference(s): DWR Levee Logs, 1993 and 2005]					
FS Date: 3/15/2013

Underground service alert (USA) blue paint indicators of water line present on landward side.

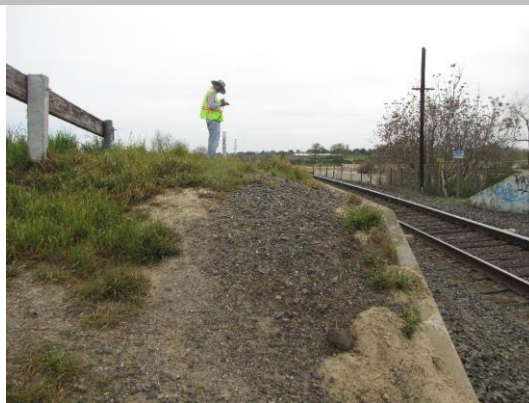
Photo 2 of 3 : UCIP_SP_2018_40975_72695.jpg

LM Start	0.58	Rating **	M	Issue No.	46	
LM End	0.58	Issue Type +	En	Location *		
Category	Supplemental			GPS Latitude/Longitude		
				Start	End	
Item	DWR UCIP Field Study			39.136556 °	39.136556 °	
				-121.583626 °	-121.583626 °	
DWR ID						
Comment Code						
Inspector Comment						
FS_ID:40975						
DS_ID:25059						
EP_NO: N/A						
Repair Type: Non-Urgent						
Crossing Status: Indicator Found						
UCIP Comments: Need to coordinate with owner to determine status of crossing, details of crossing (install date and pipe size) and CVFPB permit number issued.						
FIELD_STRUCT_DESC: Communication line marker found near levee crown.						
FS Date: 3/14/2013

LM Start	0.58	Rating **	M	Issue No.	46 (cont)
LM End	0.58	Issue Type +	En	Location *

View of landward side.

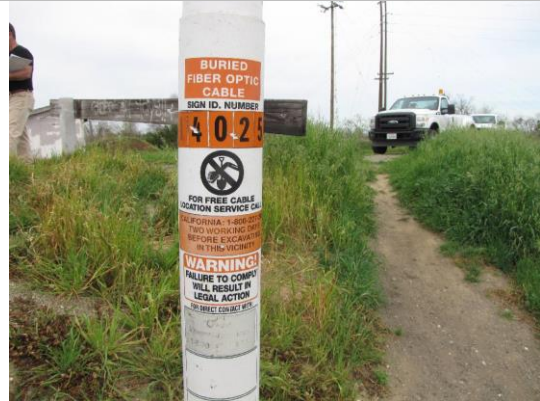
Photo 3 of 3 : UCIP_SP_2018_40975_72694.jpg

LM Start	0.58	Rating **	M	Issue No.	46 (cont)	
LM End	0.58	Issue Type +	En	Location *		
Category	Supplemental			GPS Latitude/Longitude		
				Start	End	
Item	DWR UCIP Field Study			39.136556 °	39.136556 °	
				-121.583626 °	-121.583626 °	
DWR ID						
Comment Code						
Inspector Comment						
FS_ID:40975 DS_ID:25059 EP_NO: N/A Repair Type: Non-Urgent Crossing Status: Indicator Found UCIP Comments: Need to coordinate with owner to determine status of crossing, details of crossing (install date and pipe size) and CVFPB permit number issued. FIELD_STRUCT_DESC: Communication line marker found near levee crown. FS Date: 3/14/2013

Fiber Optic Cable marker visible on landward side.

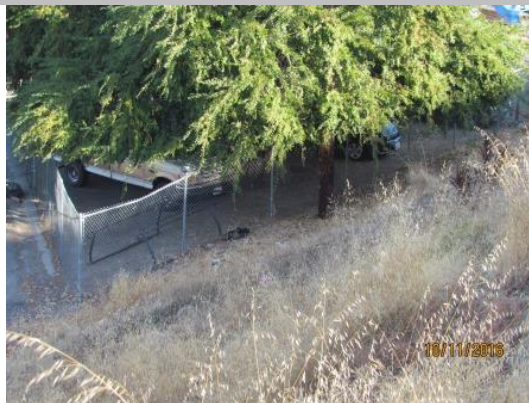
Photo 2 of 2 : SP_2018_NA0004_106_35_20180302_00013.jpg

LM Start	1.29	Rating **	M	Issue No.	35 (cont)	
LM End	1.33	Issue Type +	En	Location *	LS	
Category	Earthen Levee			GPS Latitude/Longitude		
				Start		End
Item	Encroachments			39.145757 °		39.146233 °
				-121.581280 °		-121.580724 °
DWR ID	DWR_NA0004_03_f_2016_35					
Comment Code						
FE : Fence						
Inspector Comment						
Unpermitted fence encroaches on the levee toe.

View of fence on the landside toe.

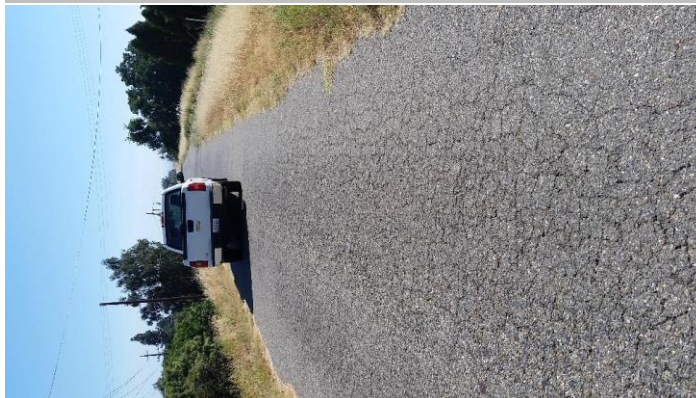
Photo 1 of 3 : UCIP_SP_2018_49951_75777.jpg

LM Start	1.59	Rating **	M	Issue No.	47 (cont)
LM End	1.59	Issue Type +	En	Location *

View of levee crown at crossing.

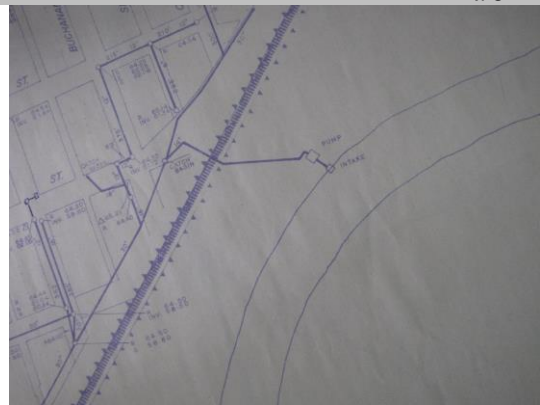
Photo 1 of 1 : UCIP_SP_2018_45363_17200.jpg

LM Start	1.60	Rating **	M	Issue No.	48
LM End	1.60	Issue Type +	En	Location *	
Category	Supplemental			GPS Latitude/Longitude	
				Start	End
Item	DWR UCIP Field Study			39.149063 °	39.149063 °
				-121.577190 °	-121.577190 °
DWR ID					
Comment Code					
Inspector Comment					
FS_ID:45363 DS_ID:19142 EP_NO: 7066 Repair Type: Non-Urgent Crossing Status: Indicator Found UCIP Comments: Unable to take coordinates due to limited access to waterward side, used desk study coordinates. FIELD_STRUCT_DESC: 14-inch drainage pipe through levee, 6 feet below levee crown. Discharges into Ellis Lake. Slant pump mounted on metal pump stand located approximately 150 feet from waterside toe. (14-inch pipe authorized under Permit No. 7066B, 7066A, 7066, 1970-City of Marysville). [Additional Reference(s): DWR Levee Logs, 1993 and 2005] FS Date: 3/14/2013

As-built dwg provided by Marysville Water Waste Treatment Plant.

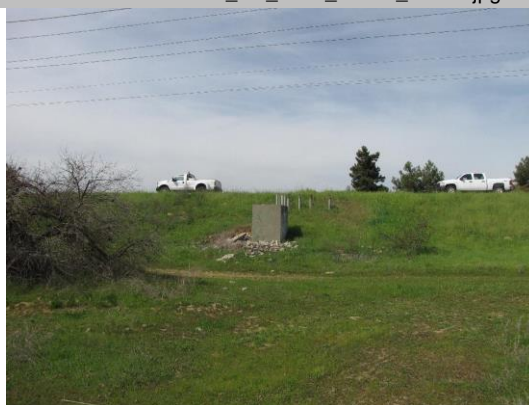
Photo 2 of 3 : UCIP_SP_2018_40998_69834.jpg

Concrete box and vent pipes located on waterward slope.

Comment Code						
Inspector Comment						
FS_ID:40998 DS_ID:19160 EP_NO: 2149 Repair Type: Non-Urgent Crossing Status: Indicator Found UCIP Comments: Depression observed on waterward toe filled with concrete rubble and riprap. Need to coordinate with City to determine records and extent of modifications if any. FIELD_STRUCT_DESC: [17th & Howell Pump Station] 2 of 4: 10-inch steel drainage pipe, buried 15-feet below the crown. Runs parallel to other drainpipes, encased in concrete approximately 1-foot spacing. Pipe extends from storm water pump house to manhole (259 feet) north of landside (LS) toe. Flap gates and vent pipes at waterside (WS) toe. Discharges into concrete distribution box (3-foot by 4-foot). (three 30-inch and one 10-inch pipes and a 48-inch outfall pipe across the berm along the right bank of the Yuba River authorized under Permit No. 2149, 1956-City of Marysville). [Additional Reference(s): DWR Levee Logs, 1993 and 2005] FS Date: 3/14/2013

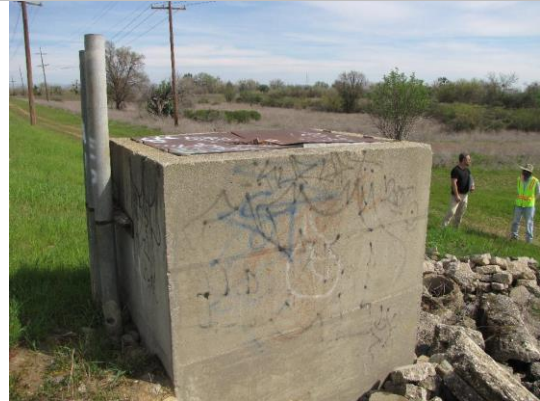
Photo 3 of 3 : UCIP_SP_2018_40998_69833.jpg

Concrete box located on waterward slope.

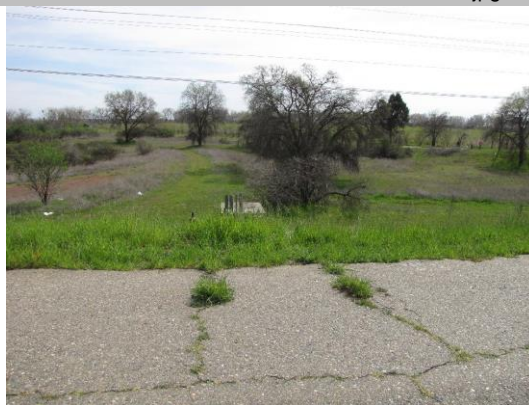
Photo 2 of 3 : UCIP_SP_2018_41001_69826.jpg

View of waterward side.

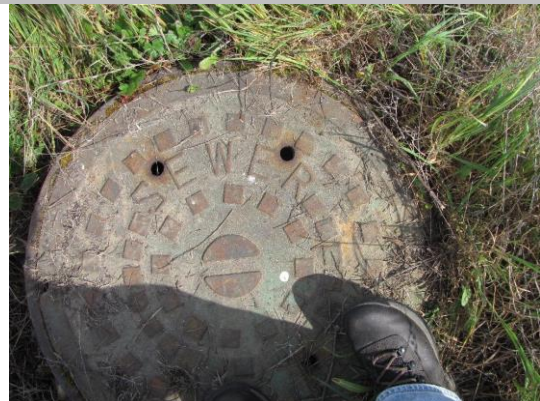
Photo 1 of 2 : UCIP_SP_2018_41002_25149.jpg

Comment Code					
Inspector Comment					
FS_ID:41002 DS_ID:19116 EP_NO: 15010 Repair Type: Non-Urgent Crossing Status: Found UCIP Comments: Need to contact owner to determine status. Manholes present at the following locations: 39.166742598 -121.55771393, 39.165767008 -121.558388687, 39.164557033 -121.559197594 FIELD_STRUCT_DESC: 8-inch fusion welded polyethylene gravity sewer pipe through levee, 8-feet below the levee crown. Shut-off valve within manhole located 46-feet waterside (WS) of levee shoulder. Encased in reinforced concrete through levee section. Extends parallel to levee, 10-feet from toe. (6-inch sewer and 12-inch water line authorized under Permit No. 15010, 1989-City of Marysville, 8-inch pipe installed instead of 6-inch pipe per permit records). [Additional Reference(s): DWR Levee Logs, 1993 and 2005] FS Date: 3/14/2013

Manhole located on landward toe.
